How we got here

Disassembly

Reassembly and Fabrication

The Technical bits

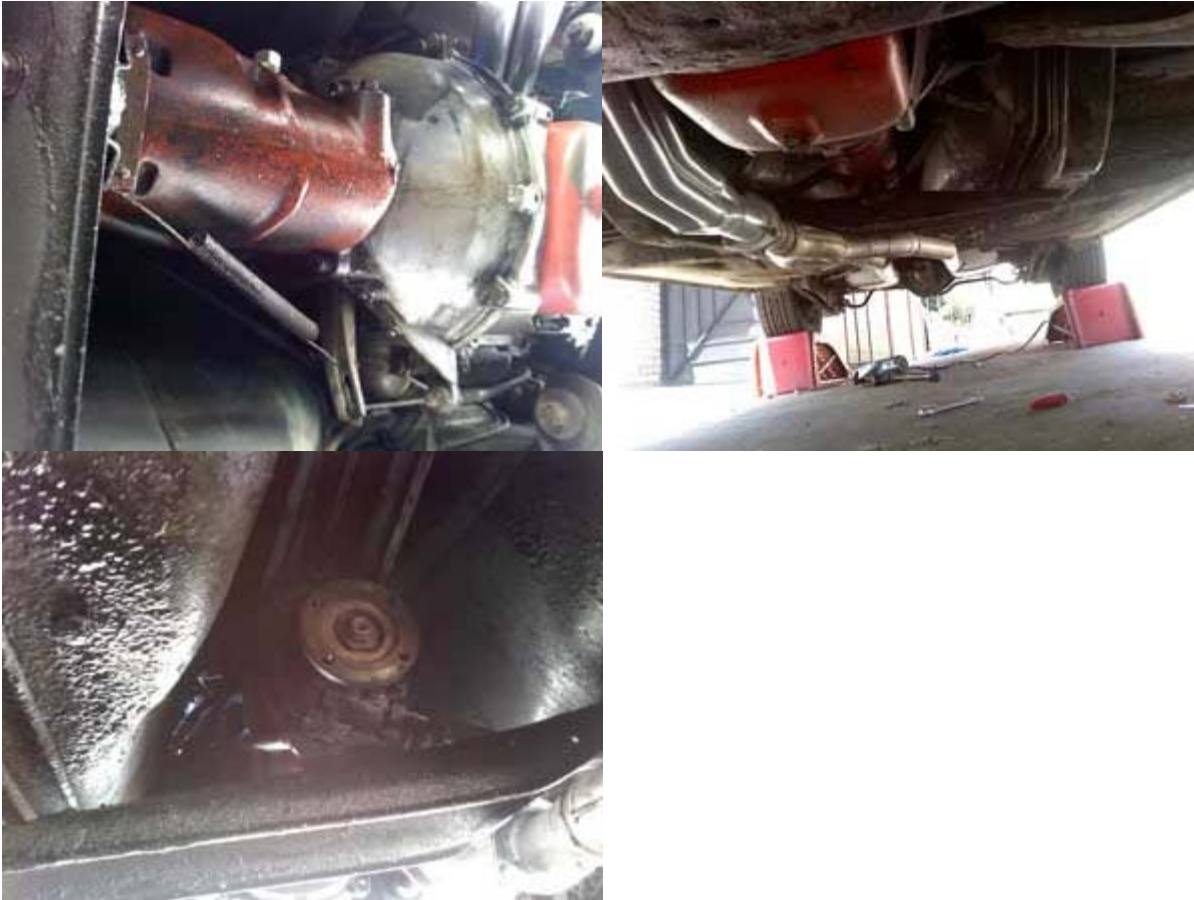
Disconnected the battery and pulled the 940 turbo mini starter. Removed the driveline, disconnected the clutch cable, speedometer cable, and brakelight switch. Removed the cross member and clutch return spring. Unbolted the transmission from the bell housing, little bugger doesn't hardly weight a thing

compared to the T-5, removed the bell housing after a little coaxing with a mallet. Removed the pressure plate and disc, then unbolted the flywheel. Discovered after getting the flywheel off, that at some point someone had been kind enough to update the rear main seal and housing to the new style, no leaks so I felt it was best left alone, also explains why the bolts on the back of the pan were different when I did the pan gasket a few months back. Found the flywheel was a bit rough, the clutch had only been changed once up to this point and my love of driving in the mountains probably was not helping. When it came to removing the pilot bearing, a blind hole bearing tool with its mini slide hammer made life easy, loaner from Autozone.

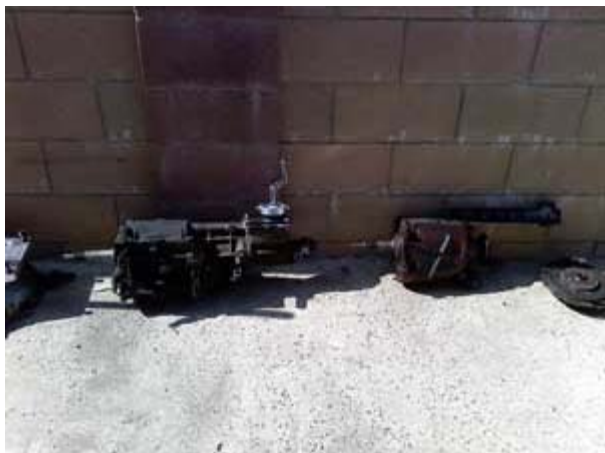
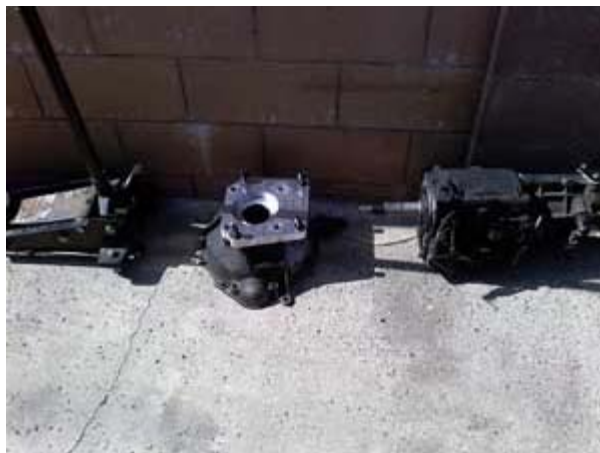
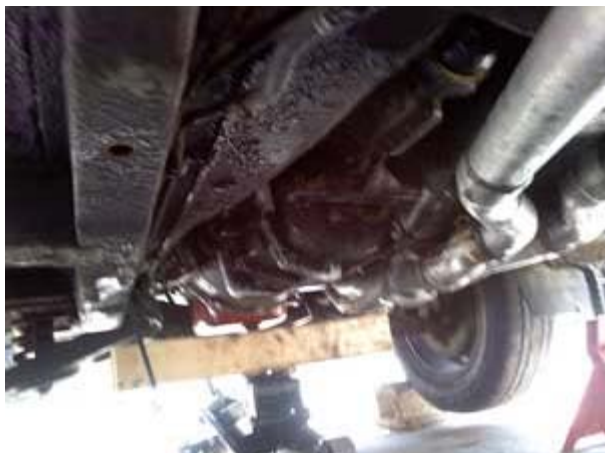
Now the fun begins, fitting the 5.0L transmission behind the tiny B20F. That adapter from Avalanche fit perfectly with the socket head bolts from the local bolt store. We heaved the transmission in once without clutch and flywheel to test the fitment of the plate, all good.

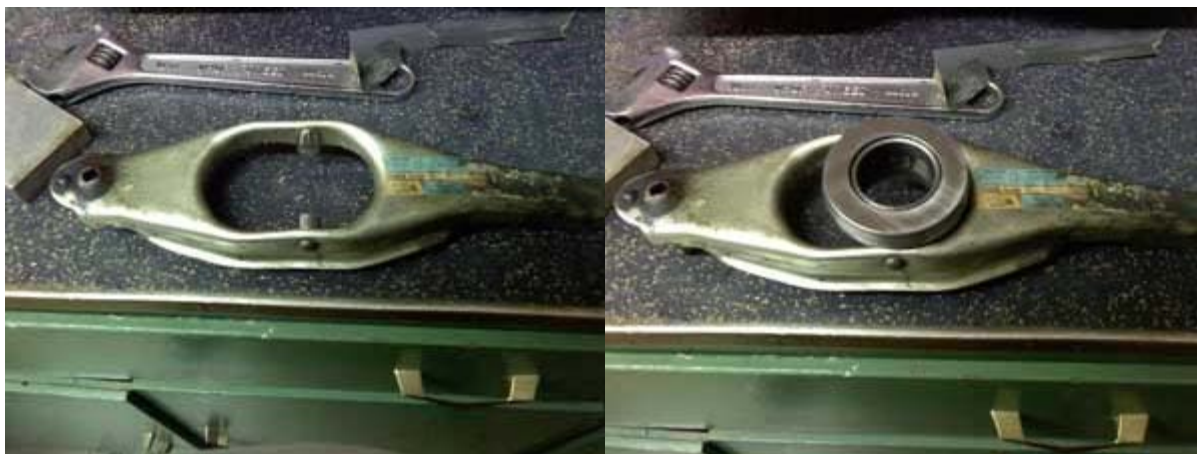
Next step, the clutch fork. Tapping into my grandfathers 30+ years of machining experience I provide him with the fork, release bearing and a vague idea of what we needed to accomplish and he provided a simple yet surprisingly effective solution. To increase the diameter of the pins to fit the bearing he found a piece of 3/8" stainless steel tubing which we cut down and then pressed over the pin with a C clamp bringing the pin diameter to nearly dead on for the bearing channel. The next step was to grind and then hand file the pins with shims down until the gap between them was a few thousandths bigger than the diameter of the bearing at its narrowest. A dial caliper helps in checking measurements, the objects was the leave clearance for a little variation in bearing construction but still be a good fit.

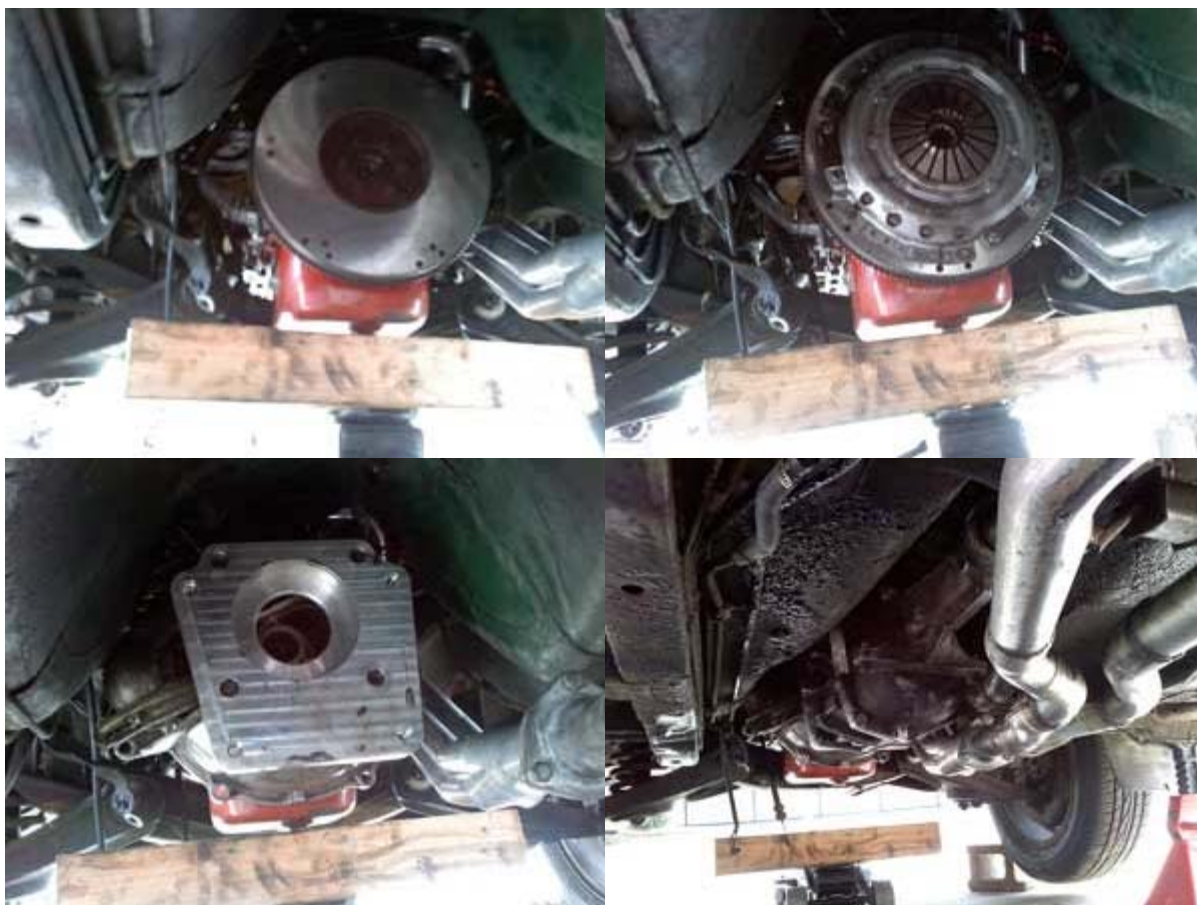
With the Fork sorted out assembly could begin. Clutch was assembled as one does making sure to not snap off the bolts due to over tightening. Next came the Bell housing and plate, then the joys of clearing the transmission past the exhaust AND lining up the input shaft, needless to say we have become quite good at this part. To make life easier a 24" 3/8" extension with a flexible 3/8" extension on the bolt end were used to tighten the transmission to bell housing bolts snug, then the flexible extension was removed and dual universal joints on a 6" extension were used for the final torque of the bolts. The Flexible extension allowed for two shallow bends around the casing of the transmission without binding which the universal joints do in the same position and the 24" extension allowed the ratchet to be brought out into the open area behind the tail shaft.

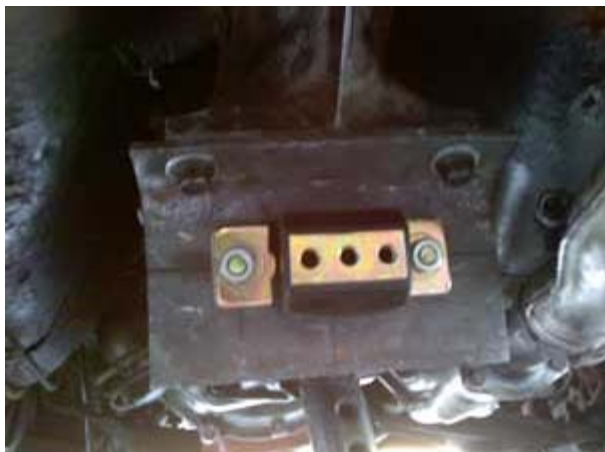
After all that fun I still had to fabricate a mount to keep this thing in place. I spent quite a bit of time toying with the possible configurations before deciding on an attempt to attach to the stock position on the cross member. I then bent a 8" x 6" piece of 1/4" plate steel (probably overkill) with hand tools to the angle close to the stock set up. This was accomplished by clamping the steel to a very sturdy mount, the frame of my Grandfather's Freightline, and using a 24" crescent wrench with a three foot pipe over the

handle to bend the metal. Not the most efficient way, cost effective yes, practical no. It's not pretty but it works, although, if you have access or fund available, machines are your friend. At first I was going to use a pair of stock mounts but after considering how well the energy suspension mounts have held up on my truck I decided to go with the spare poly transmission mount which I had for another project.

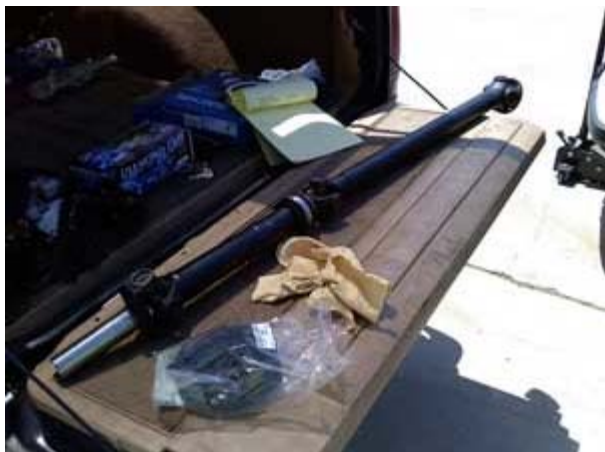
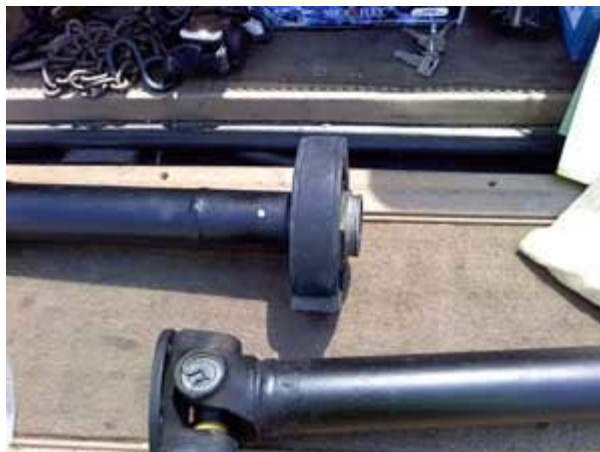
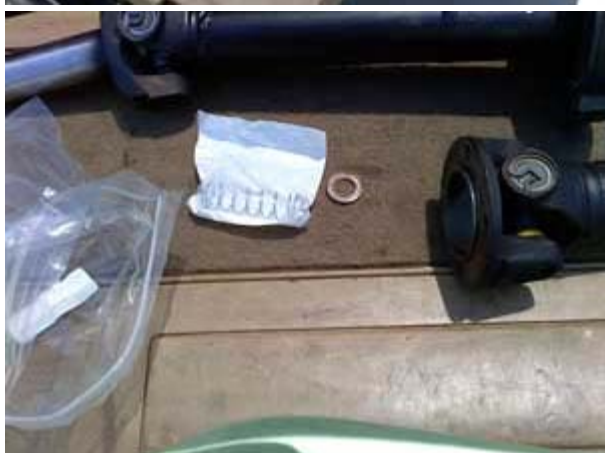
Now that I had everything relatively where it needed to be the driveline needed adjustment. I took a few measurements and went to the local driveline shop to have the length shortened and while I was at it a new carrier bearing installed as well as the Ford yoke and new u-joints. The Ford slip yoke requires a larger joint than the stock drive line uses, thankfully the shop had a conversion joint which allowed for mating the two different breeds together. Also don't let the shop talk you into a one piece shaft if you have a 140, the parking brake cables and a structural cross member would get in the way of a single piece shaft if it had to articulate down any measurable distance. Once the driveline was completed I was able to determine I had to drill a hole lower on the cross member to get the driveline lined up correctly. Since the mounting location is lower I made a 1/4" thick reinforcement plate to be welded in place once all adjustments are completed. Now with the mounting completed final assembly and functional checks begin.

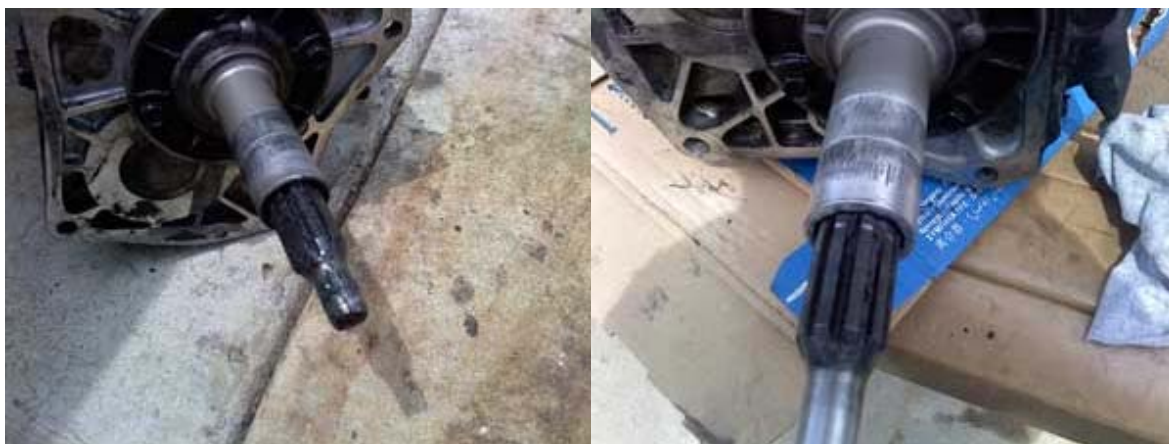
We lower the car onto the ground, reinstalled the shift arm onto the shifter and proceed to move the shift through the gears with not a hint of resistance. This point should have been when I realised things were going way too easily. Put her in neutral and try to start the car. She fired up, YAY! Try to put her in first, the shifter would not go into gear. Shut down and the shifter goes in, start the car foot on clutch barely fires, release the clutch and she move but something doesn't feel or sound right. Spent two days playing with the clutch cable and even shimmed the clutch fork pivot thinking it was a lack of engagement. After Several attempts at shimming the fork pivot we called it a night.

Then a breakthrough at the point of giving up, thinking about it at heaven knows when in the middle of the night I ran over what we found. When we tried to roll the car in neutral something was dragging. A thought had come to me, was something hitting the clutch disc? Was something holding pressure on it, keeping it pressed to the flywheel? The next day I had time to get to it peering through the Clutch fork hole revealed little. We disconnected the rear shaft section and while holding the clutch pedal an attempt was made to turn the driveline, it wouldn't move even in neutral. Pulled the transmission for the N'th time in the project and took the alignment tool for the clutch and slid it into the clutch and marked the position in relation to the clutch disk splined hub. Then compared to the input shaft. The tool slid into the clutch approximately 1/16" further than the sleeve on the input shaft would allow, inserted a ruler to verify. The Input Shaft sleeve was hitting the center hub of the clutch disk and pressing the disc into the flywheel. Simple solution, pipe cutter the shave off 1/8" from the sleeve and then the transmission is reinstalled, checked by turning the driveline in gear with clutch pedal pressed, problem solved. With the Car back on the ground, engine running, release the clutch pedal, she moves.

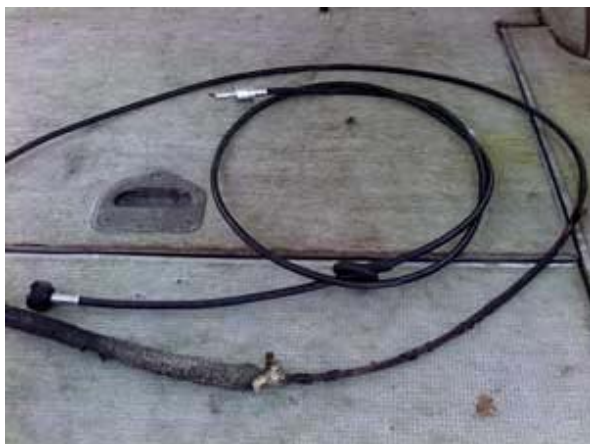
After a few weeks of driving without a speedometer I located a local speedometer shop and he made a cable the same length as the stock cable but with the correct ends to use in the T-5 without using the VSS. The cable comes out the fire wall and instead of crossing over the transmission, loops down the driver's side along the clutch cable then loops up into the transmission. The floor near where the cable meets the transmission was dimpled to allow for movement of the transmission. The speedometer is still a bit optimistic, by about 5 mph at 40, but a few gear choices are still available.

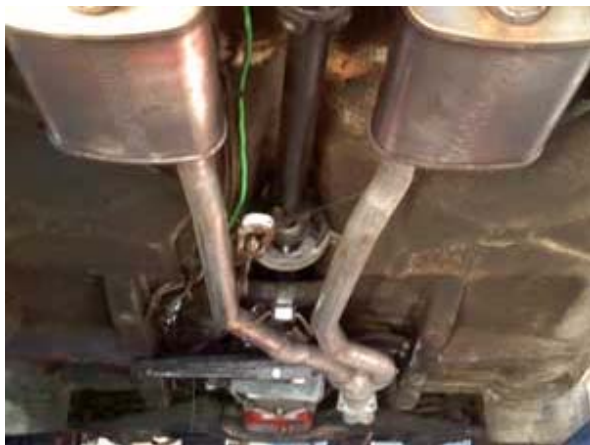
began to notice thumps on the floor and tried adjusting the transmissions position several times with little resolution. After driving another week or so I noticed the banging on the floor getting worse car but I couldn't pin it down. Then one day going to work the problems source was revealed, the noise became almost constant and after work I jacked up the car to find the driveline had slid backwards on the slip yoke and the yolk was hitting the floor. Through the clever use of zip ties I got the car home that night. Next day off I took the car to the exhaust shop and since he wasn't busy was able to put the car in the air for a better view of everything. While in the air he adjusted the cross member to clear the exhaust and vice versa and then I came up the idea to put a brace on the rear of the carrier bearing bushing to hold it in place and keep it from moving. Improvised braces in place I drove for another week with intermittent thumps and then put the car back up in the air. The problem was the slip yoke allowed the driveline to move back enough for the ears of the yoke to hit the narrow sides of the transmission tunnel. With a quick measurement of how much length was needed to put the yoke within a 1/4" of the seal on the transmission I took the driveline back up to have the front shaft lengthened. Problem solved.

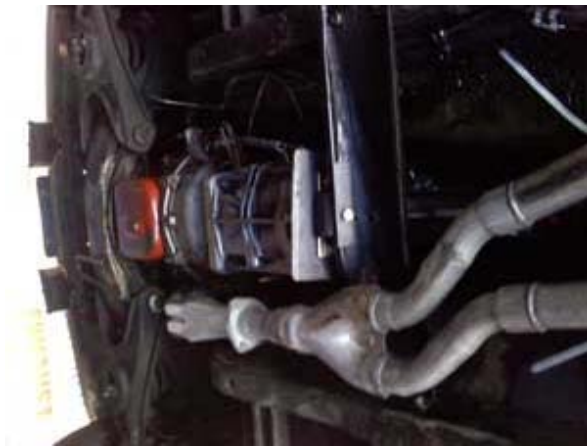
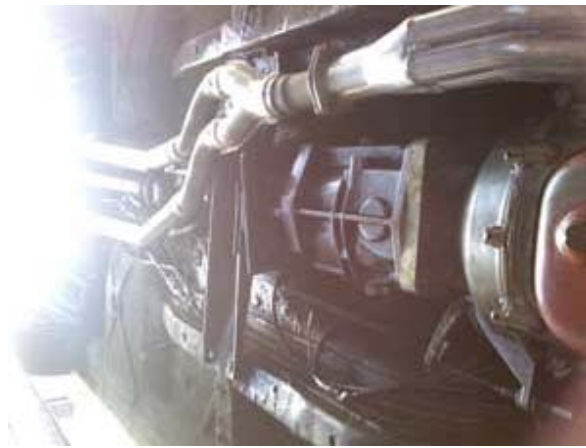
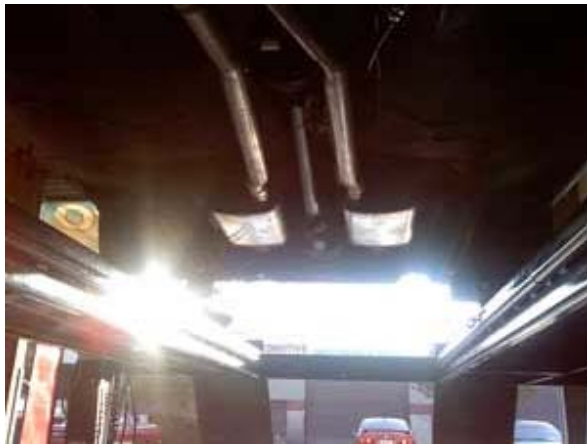
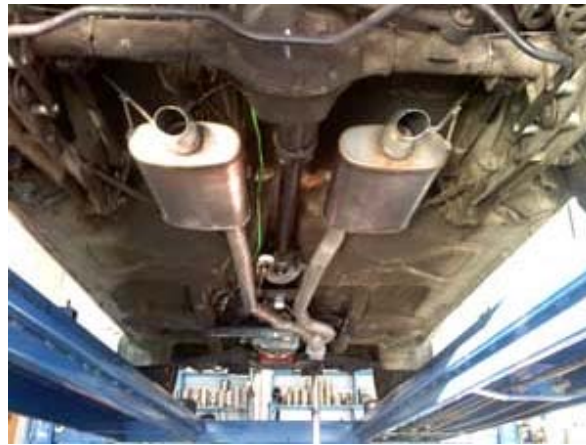
This is probably not the prettiest or most professional swap but I was shooting for function over form. With the exception of the driveline and cross member every attempt was made to make this swap completely reversible. Even the backup light switch is hooked up by using male quick connects spliced onto the ford switch wires to allow the stock wires to just plug in.

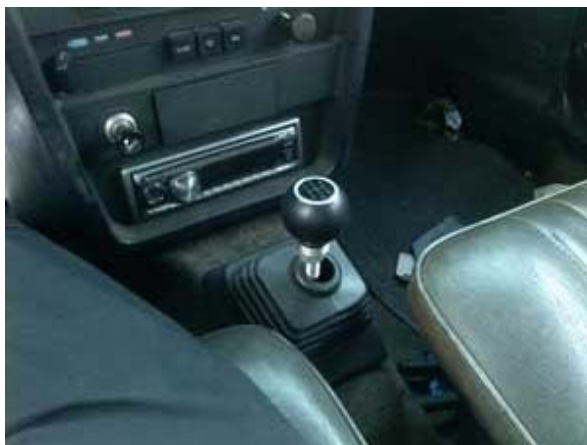
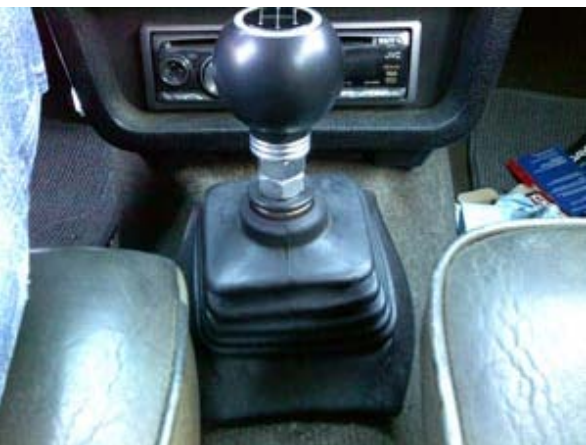
After a few days driving in December it became a bit uncomfortable to hold onto the shifter with ice cold drafts shooting in the opening left in the boot, so I got creative using a pilot bushing left over from the clutch kit for my Blazer, the bushing doesn't fit my truck but fits another vehicle the clutch kit fits. I placed an o-ring in the beveled part of the bushing with a washer and second nut on top sealing the shifter boot to the shaft, making an altogether cleaner look. Not fancy but it works.
